## Estimation of Deterioration Aspects of Granitic Columns at the Mosque of Al-Nasir Mohamed Ibn Qalawun, Cairo, Egypt

The mosque of Al-Nasir Mohammad Ibn Qalawun represents one of the important and high valuable Mamluk mosques in Egypt. The granitic columns used in this mosque provide a significant case of reusing the architectural elements dated back to the earlier Pharaonic constructions. These granitic columns have been exposed to aggressive physiochemical and mechanical weathering processes. Moreover, they have been subjected to faulty restoration with an inappropriate resinous material which led to many deterioration aspects.

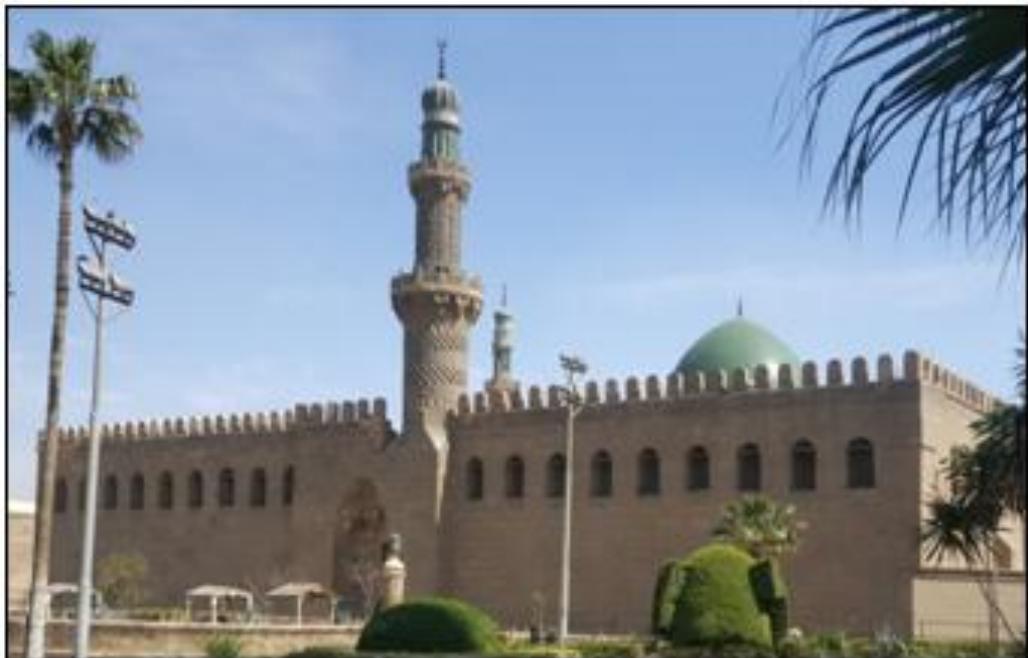
**Fig. 1:** The mosque of Al-Nasir Mohammad Ibn Qalawun.

Mosques and other architectural buildings represent the most important surviving Mamluk monuments in Egypt. The mosque of Al-Nasir Mohammad Ibn Qalawun (Fig. 1) is considered a high valuable Mamluk mosque, as it still contains numerous architectural elements from the time of its earlier foundation. It was constructed by Al-Nasir Mohammad Ibn Qalawun, the ninth Bahri Mamluk sultan of Egypt [1, 2].

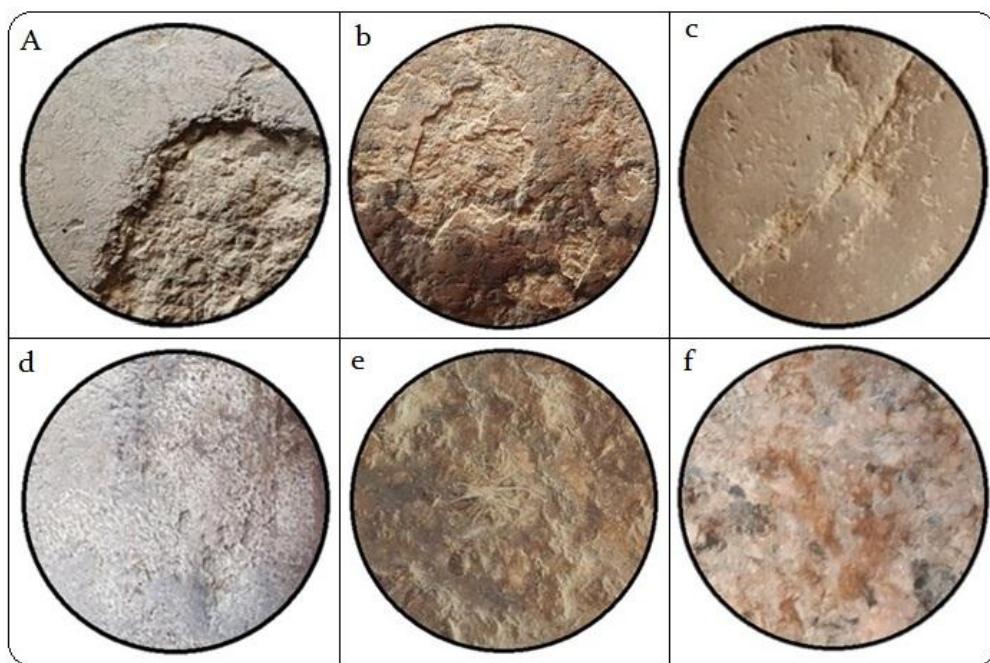
as the granitic columns were brought from the archaeological and architectural elements of earlier Pharaonic constructions at Ashmunin in Upper Egypt. They were used to bear and support the arches of the inner arcades of the mosque [6, 7]. During the Ottoman period, the mosque was highly deteriorated and lost some of its original architectural elements. In 1882 A.D., it was used as a prison and military store. In 1947, the mosque was restored by the committee for the conservation of Arab antiquities, and in 1983 it was restored by the supreme council of antiquities [1]. Due to the open courtyard of the mosque, the granitic columns are exposed to aggressive physiochemical and mechanical weathering processes that caused many damage aspects (Fig. 3) such as granular disintegration, scaling, cracking, efflorescence and soiling [8-13]. In addition, the granitic columns have suffered from the works of faulty restoration, as the columns were coated with inappropriate resinous material. Unfortunately, this unknown resinous material has been submitted to ageing processes which caused many deterioration aspects on the granitic columns such as color change, loss of aesthetical properties, accumulation of dust and microbiological colonization. (Fig. 4).

**Fig. 3. Deterioration aspects of the studied granitic columns. (a, b) scaling and granular disintegration of surficial layer at the lower parts of the granitic columns; (c) cracks and pits at the lower parts; (d) salty layer, pits and voids; (e) deposition of soot and dust on the surface; (f) spots of hematite.**

- Preventing the source of subsoil water by gradually minimizing its level.
- Desalination of halite using a suitable poultice.
- Inhibition the growth of microorganisms by utilizing antifungal and antibacterial nanomaterials.
- Removing the turpentine layer using smart materials such as nanomagnetic gels.
- Consolidation and protection by application of superhydrophobic, self-cleaning nanocomposites and/or biopolymers.

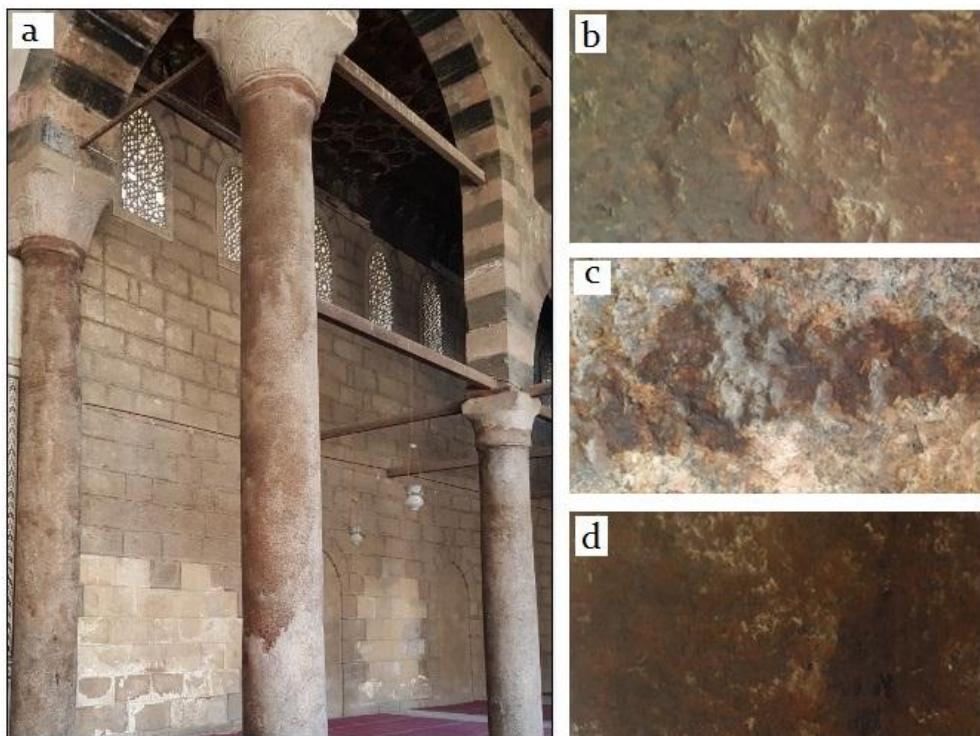
**Fig.4. (a) Inappropriate resinous material applied on the surfaces of granitic columns; (b, c, d) damage aspects of resinous material.**

In the past, turpentine was commonly applied on the Egyptian granitic monuments in order to preserve their glossy and polished appearance. This aspect of fault restoration occurred when conservation works were entrusted to non-specialist persons or contractors.

Moreover, the resinous material coating the granitic columns led to color alteration, loss of aesthetic properties, accumulation of dust and microbiological colonization. Microbiological investigation declared the presence of *Aspergillus niger*, *Penicillium sp.*, and *Bacillus sp.* on the granitic columns, especially in the places treated with resinous material.

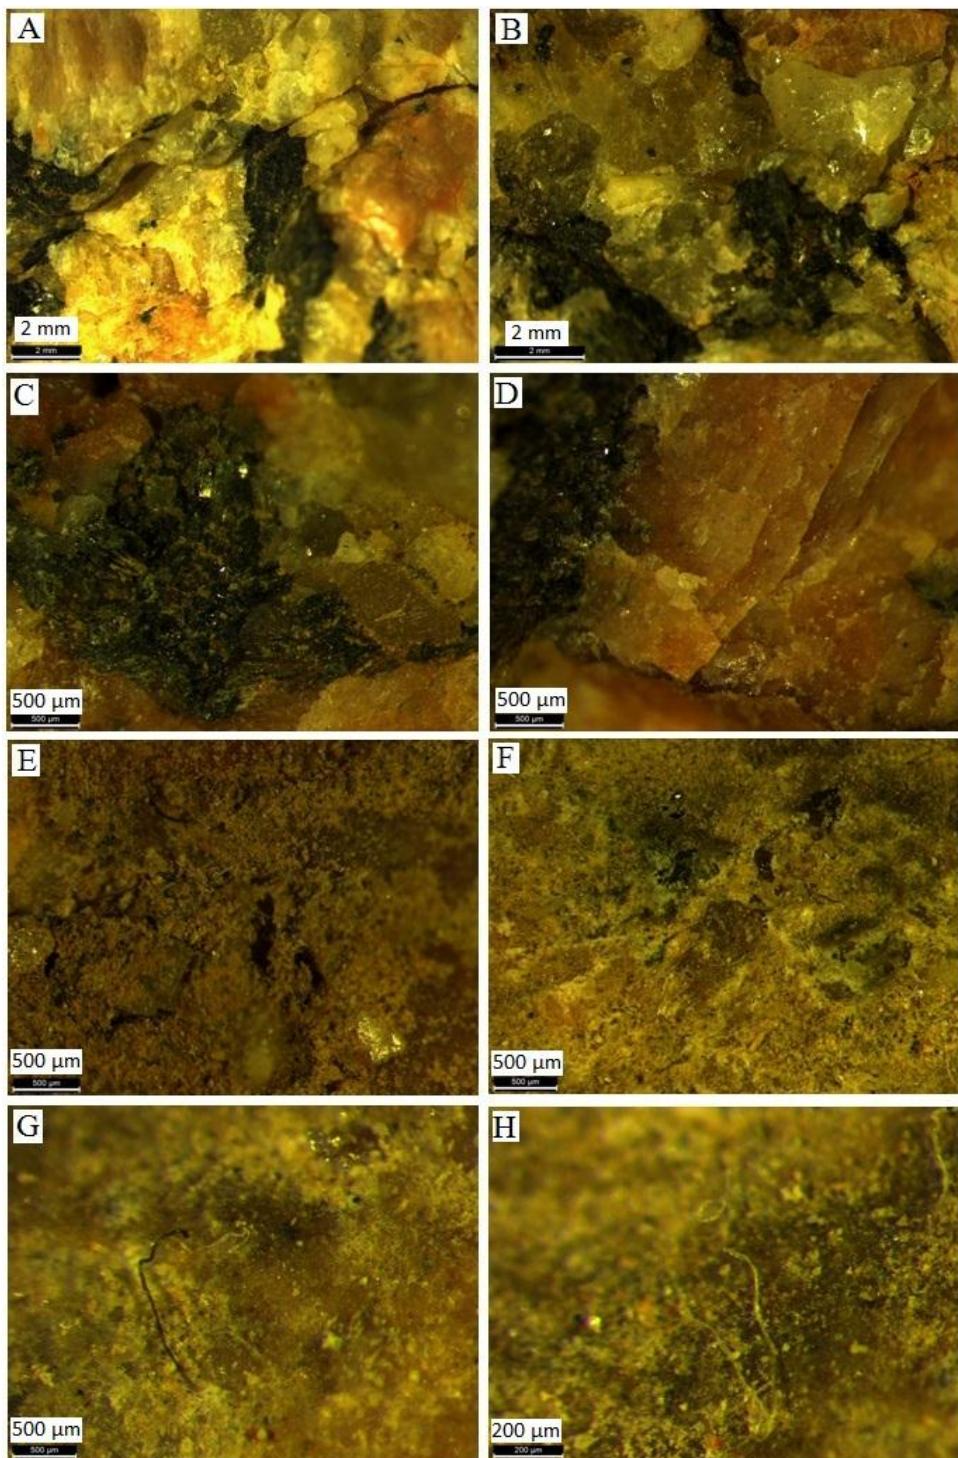
scope. The stereo micrographs (Fig. 5) show significant deterioration aspects in the granitic samples. The grains appear to be suffered from granular disintegration, flaking off, tiny cracks, pits and color alteration. Biotite grains are highly weathered, as they have many surficial deformation aspects. In addition, there is accumulation of weathering products on the grains surfaces, also in the pits and voids between the grains. In addition, the granitic samples lost their aesthetic properties, as the grains have been covered by the resinous matrix filled with soot and dust. Furthermore, the stereo micrographs declare the spreading of microbiological colonization, especially on the resinous material.

**Fig.5.** Stereo micrographs of granitic samples. (A, B) impact of mechanical deterioration that is represented in tiny cracks and granular disintegration, (c) trapping of weathering products in the pits and voids of altered and highly deformed biotite, (D) cleavage and microcracks of potash feldspar, (E, F) covering of granitic grains by resinous material mixed with dust particles, (G, H) spreading of microorganisms over the resinous material.

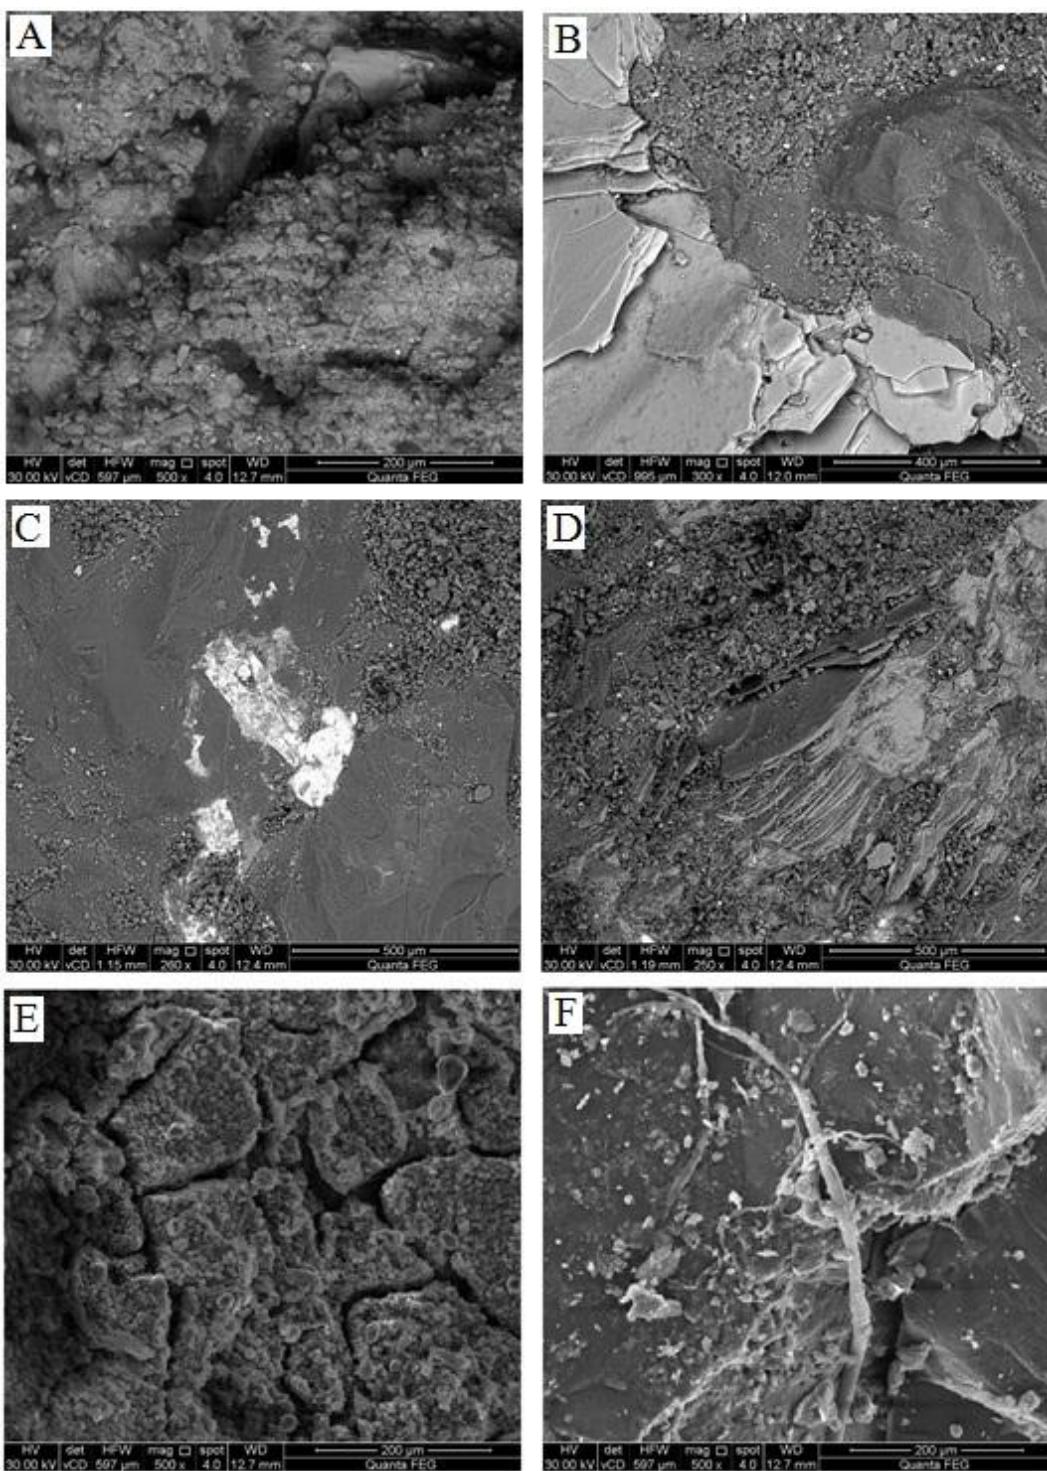
From SEM micrographs (Fig. 6), it can be clarified that the studied granitic columns were putted through hard weathering processes, as the samples appear to be very fragile and have a lot of voids, microcracks, etch-pits, salts, fungal colonization and tiny particles of weathering products (especially clay minerals).

**Fig. 6. SEM micrographs of the studied granitic samples. (A) granular disintegration, voids and mineralogical alteration aspects [500x]; (B) tiny cracks and surficial flaking [300x]; (C) crystallization of salt on the grain surface [260x]; (D) etching pits and clay minerals [250x]; (E) resinous material filled with tiny cracks [500x]; (F) spreading of fungal colonization between and over the grains [500x].**

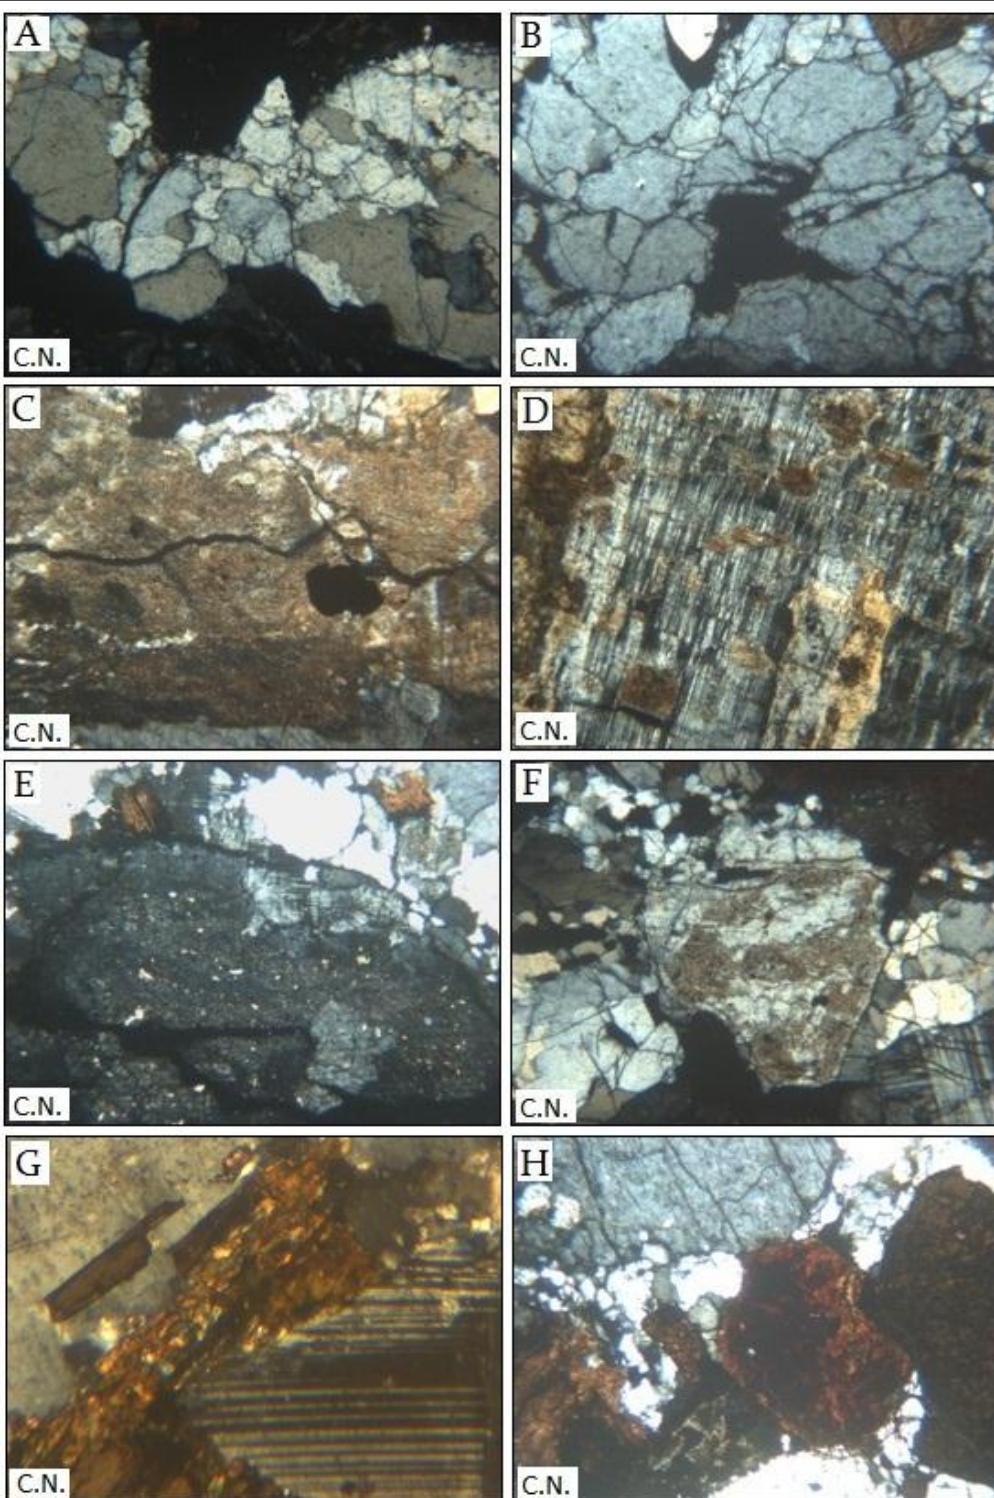
**Fig.7.** PLM micrographs of the studied granitic samples. (A, B) highly fractured quartz grains; (C) high alteration of orthoclase into sericite and clay minerals; (D) partial alteration of microcline into sericite and clay minerals (E, F) plagioclase grains suffer from slight and partial alteration to clay minerals; (G) plagioclase feldspar and deformed biotite; (H) high alteration of biotite into hematite. (Magnification 25 X).

- Quartz represents an essential mineral constituent that occurs as fine to medium-grained, anhedral crystals. It also exists as crystal aggregates between feldspar crystals. Some quartz grains have sutured, fractured and curved boundaries while others are granulated. Although quartz possesses high degree of durability, it is highly affected by cracks and fractures. High deformation of quartz clarifies the high mechanical stresses to which the granitic columns are subjected since the Pharaonic period up till now.

- Potash feldspars are the most abundant constituents in the samples. They are characterized by cross-hatching and simple twinning, respectively. They are medium to coarse-grained, generally subhedral to anhedral crystals. They appear to be partially or highly altered to sericite  $\text{KAl}(\text{AlSi}_3\text{O}_{10})(\text{OH})_2$  and clay minerals (hydrated aluminum silicate), which reflect the high impact of physiochemical weathering on the granitic minerals. In addition, the effect of weathering processes on the granitic minerals are reflected in their mechanical properties, as the grains appear containing many microcracks and surficial deformation.

- Biotite occurs in minor amount as fine to medium-grained, tabular, flaky crystals between feldspars and quartz. Due to physiochemical and mechanical weathering processes, biotite grains suffer from surficial deformation and microcracking. It is converted to reddish brown hematite ( $\text{Fe}_2\text{O}_3$ ).
- Hornblende occurs as a minor constituent, it presents as fine to medium-grained aggregates, prismatic crystals associated with biotite. It is slightly to highly altered to hematite.
- The high content of mineralogical alteration of feldspars to clay minerals illustrates the reason of grey color layers formed on the surface of studied granitic columns.

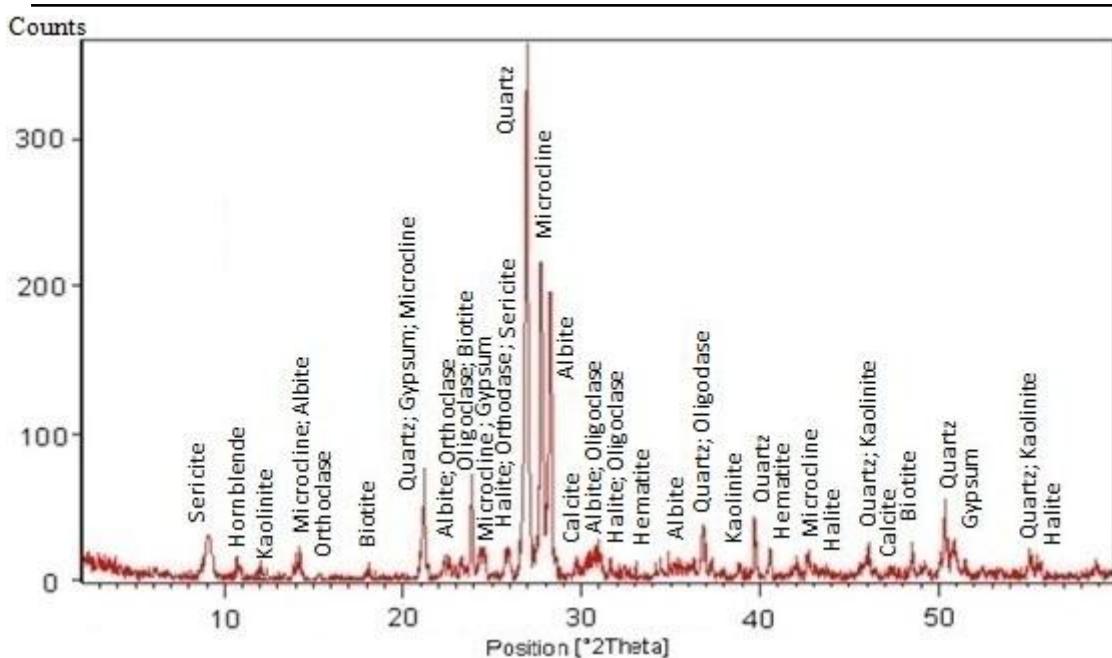
X-ray diffraction pattern (Fig. 8) reveals that the studied granite is mainly composed of quartz (30.2 %), microcline (21.2 %), orthoclase (6 %), albite (13.3 %), oligoclase (10.1 %), biotite (3.1 %)

and hornblende (2.1 %). On the other hand, sericite (2.3 %), kaolinite (2.2 %), calcite (2 %), gypsum (3.2 %), halite (2 %) and hematite (2.3 %) are detected as weathering products. Presence of the previously mentioned secondary minerals reflects the hard physiochemical weathering processes affecting the studied granitic columns. Water (from the different resources such as rain, relative humidity, ground water) and atmospheric pollutions (such as  $\text{CO}_2$ ,  $\text{SO}_2$ ,  $\text{NO}_x$ ) are the main factors of physiochemical weathering. The high rates of fossil fuel combustion related to the urban and industrial developments, led to increasing the concentrations of carbon dioxide, sulphur dioxide and nitrogen oxides. The dissolving of these gases in water giving rise to the formation of acidic solutions, which play the significant role in mineralogical alteration of granite [14]. The formation of sericite in the granitic columns is attributed to the hydrolysis of potash feldspars and biotite, which finally causes their mineralogical alteration [15].

In addition, kaolinite is formed due to the alteration of feldspars and biotite in later stage of physiochemical weathering [16]. Calcite is formed due to the reaction between carbonic acid and Ca-bearing feldspars [17]. Moreover, it can be suggested that the formation of gypsum in the studied columns is a result of the reaction between sulfuric acid and Ca-bearing feldspars [18]. Halite can arise on granite surface from subsoil water rich in sodium and chlorine. Also, it probably occurs as a result of the reaction between chlorine anions (from different sources) and sodium ions in Na-bearing feldspars. On the other hand, the presence of hematite is ascribed to the leaching of iron from the crystal structure of biotite at the early stage of weathering processes. Oxidation of ferrous ions to ferric ones forming hematite stains on microfracture cleavages [15].

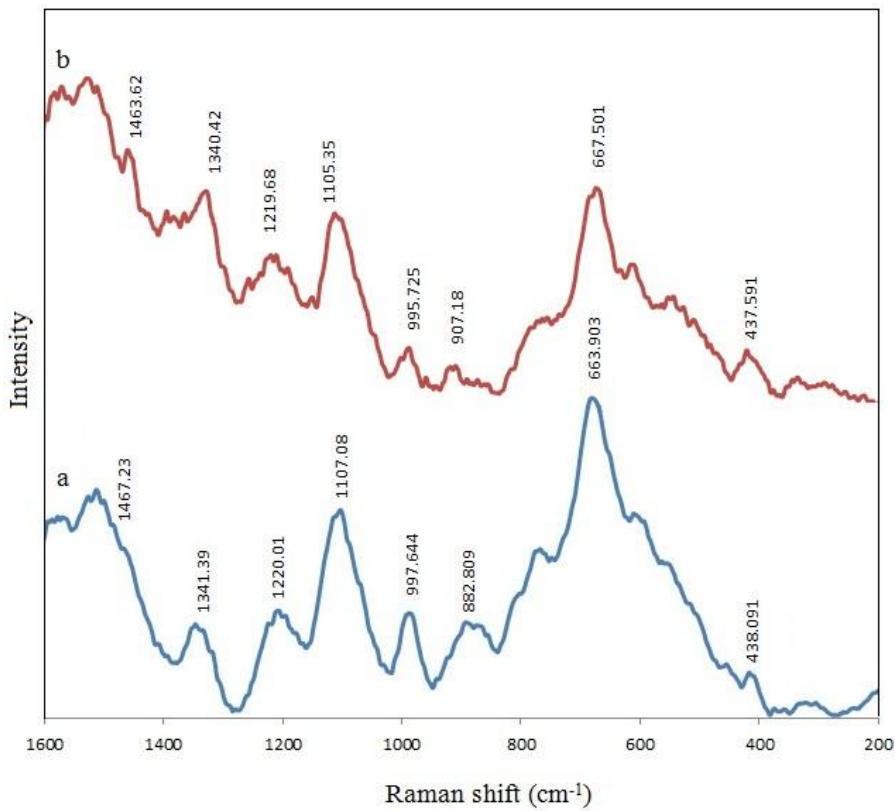
By studying the databases of Raman analysis that have been established by previous studies [31], it can be seen that the spectra of studied resin includes the same main characteristic bands as terpenoid, especially turpentine. Therefore, Raman spectra of the studied resin is compared with the spectrum of turpentine that is widely used in the restoration works at Egyptian archaeological sites. The comparative study clarifies that the compared samples are highly similar, as their Raman bands are observed in the same positions, as seen in Fig. 9. The bands in the region between 1480 and 950  $\text{cm}^{-1}$  can be attributed to  $\delta(\text{CH})$ ,  $\delta(\text{CH}_2)$  and  $\delta(\text{CH}_3)$  deformations and  $\nu(\text{CC})$  stretching vibrations [31]. The difference between the studied resin spectra and the reference spectra of turpentine sample could be due to the impact ageing processes on the studied resin [30, 32].

**Fig. 9: Raman spectra of (a) Turpentine reference sample, and (b) resinous material on granitic columns.**

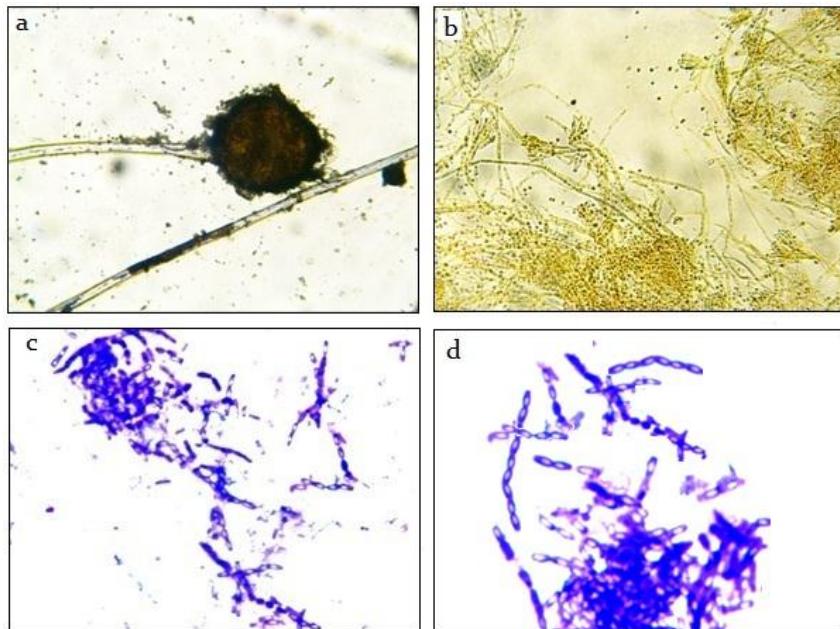
Microbiological study of granitic samples showed high density of fungal and bacterial growth. Two types of fungi (*Aspergillus niger* and *Penicillium sp.*) and one type of bacteria (*Bacillus sp.*) were identified by optical microscope (Fig. 10). The growth of microorganisms on granitic stones led to physical, chemical and mechanical degradation aspects. They caused undesirable aesthetical alterations of outer surfaces of granite. In addition, they produced high amounts of organic acids that accelerate the alteration of feldspars into clay minerals [13]. What's more, they contributed to the mechanical damage of granite due to the pressure associated to their growth inside the pores and beneath decomposed layers [11, 13].

**Fig.10: Optical micrographs of (a) Aspergillus niger; (b) Penicillium sp.; (c, d) Bacillus sp.**
